OTIS COMPANY DAM NO. 1

NH 00041

PHASE I INSPECTION REPORT
NATIONAL DAM INSPECTION PROGRAM

MARCH 1979

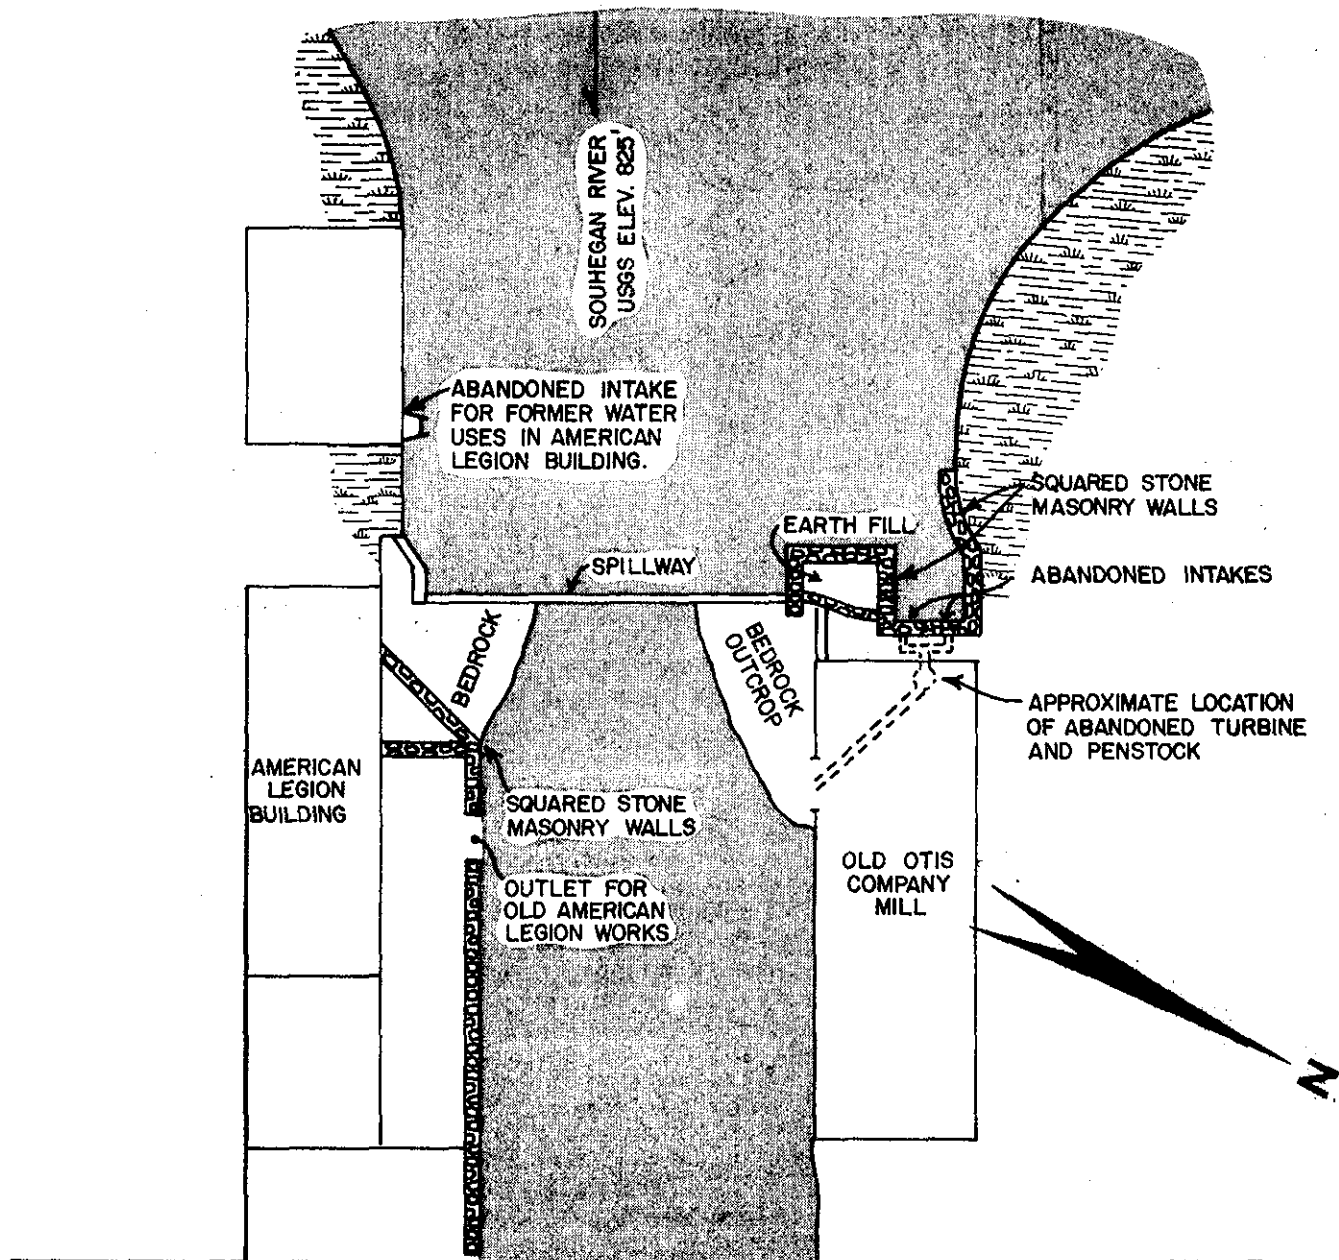
Otis Company Dam No. 1 lies on the Souhegan River in Greenville, New Hampshire. The dam lies approximately 170 feet upstream from the bridge that carries N.H. Route 31 over the Souhegan River in Greenville. The portion of USGS Peterborough, N.H. quadrangle presented previously shows this locus. Figure 1 of Appendix B presents a detail of the site developed from the inspection visit and the quadrangle map.

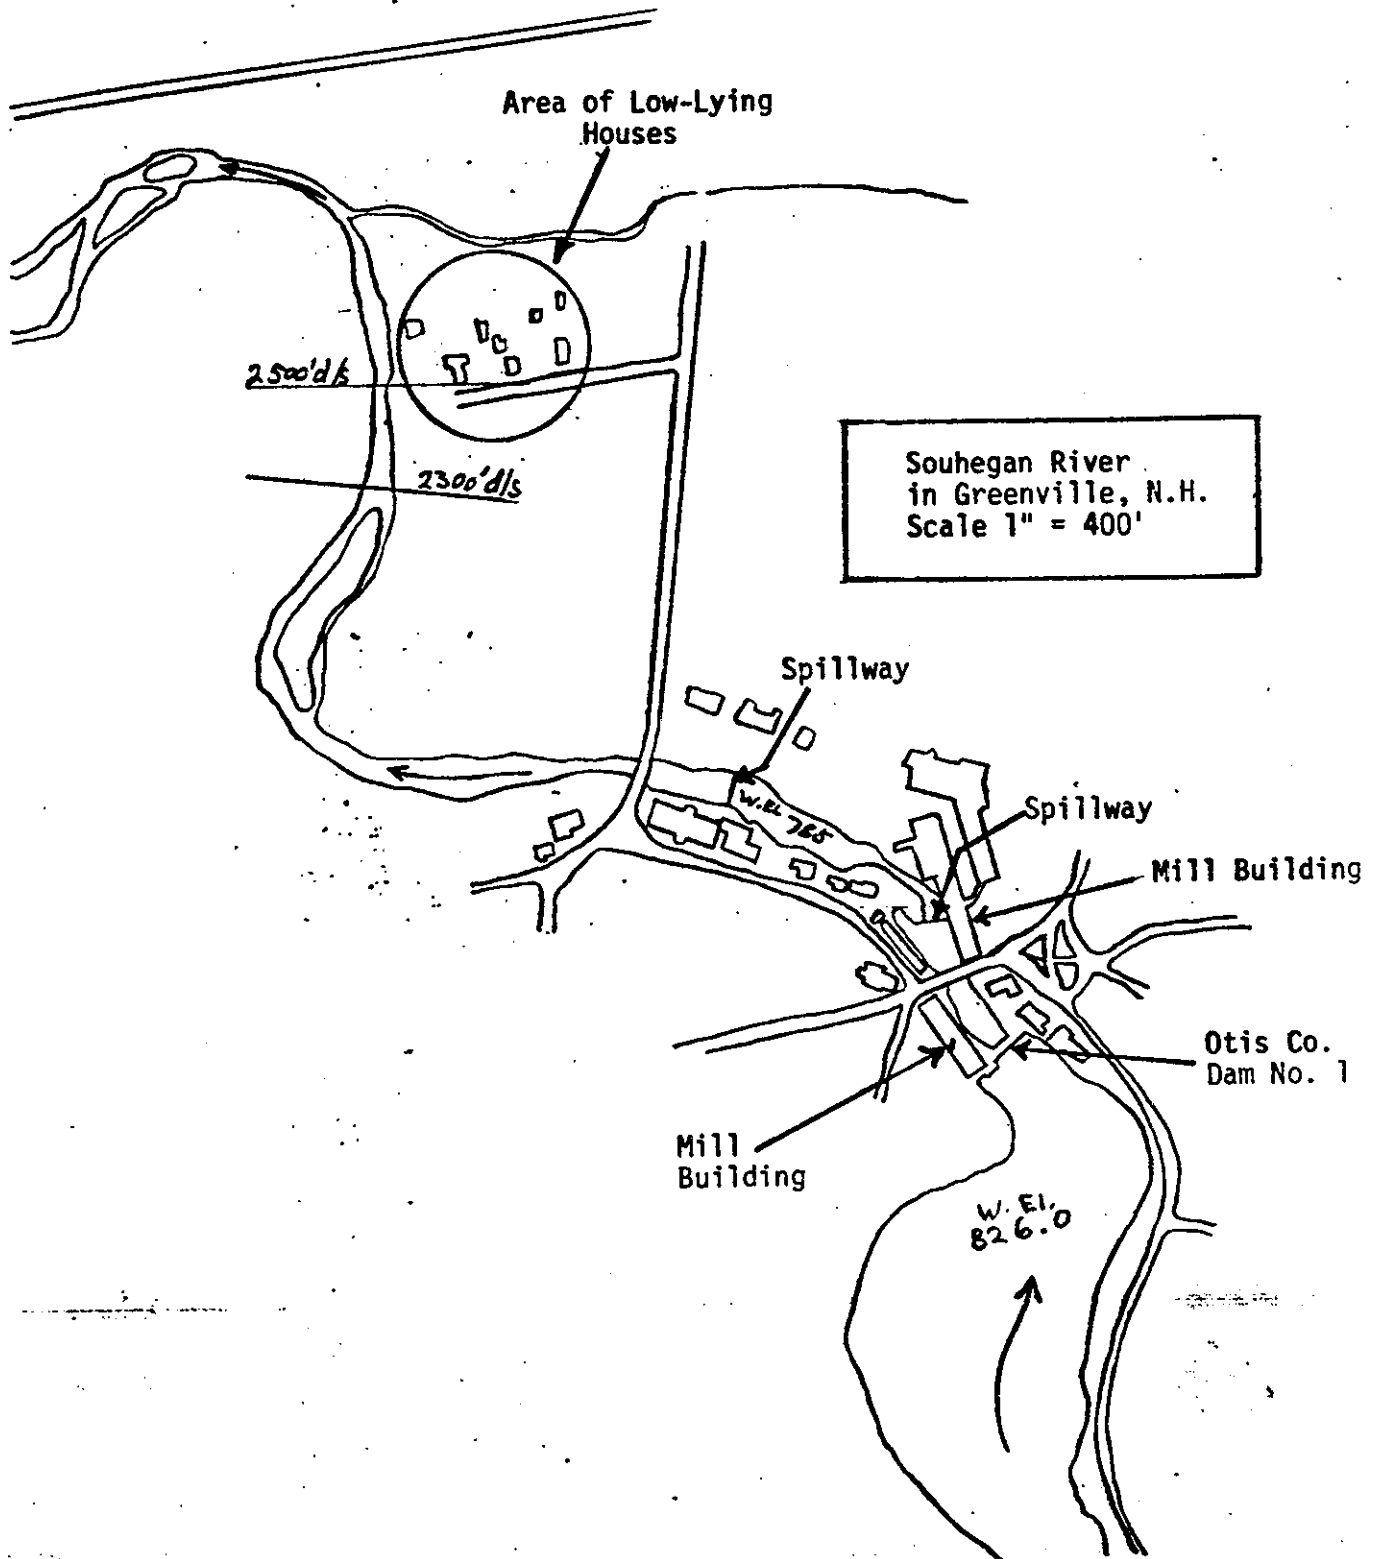
Elev. of lower chord of bridge = 518.8

With the water surface at this elev., there is a head of 14.2' above the dam and 14.6' ± above the natural overflow section
